Air Transportation Safety Investigation Report A1800106

IN-FLIGHT SEPARATION OF RIGHT WING

Quad City Challenger II (advanced ultralight), C-IGKT
North Bay, Ontario, 14.3 nm E
30 July 2018

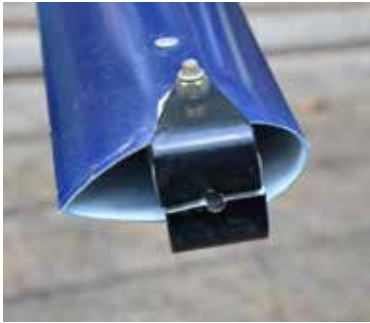
- A clean and straight fracture line went through the centre of the bolt hole on the bracket. There were no signs of plastic deformation shown on the bracket (Figure 4).
- Arced beach marks indicate that the edge of the bolt hole being the origins of the fatigue. The number of beach marks also indicated that the fatigue had begun some time before the occurrence, although the exact timeframe could not be determined (Figure 5).

Figure 4. Fractured right front lift strut bracket

The examination concluded that the bracket that attached the right forward strut to the heavy load saddle on the fuselage had failed under nominal loading condition due to the presence of a large fatigue crack. The fatigue crack, which accounted for at least 60% of the cross-section of the base of the bracket, had been present in the bracket for some time before this occurrence. The secondary delamination cracks that were found in the bracket are considered abnormal for aluminum alloy.

The failure of this bracket allowed the lift strut to detach from the fuselage and the right front spar to twist and rotate upward under aerodynamic load. The right front spar tore away at the bracket attachment point to the main centre beam and caused the wing to fail. Meanwhile, because the right-wing lift forces were no longer being transferred to the fuselage, the lift forces generated by the left wing caused the aircraft to roll to the right. As the right wing continued to fold back, the rear spar and rear lift strut failed, and the wing separated from the aircraft. This right wing separation resulted in an unrecoverable loss of control and collision with terrain.

It was determined that the fatigue crack on the right front lift strut bracket went undetected during the routine inspection cycle undertaken by the pilot and failed before the 500-hour stipulated life span. Although a bolt longer than specified had been used to attach the bracket to the lift strut, there was no evidence to indicate that the bolt had been overtightened or over-torqued. It could not be determined whether the hard landing the day before the accident contributed to the bracket failure.

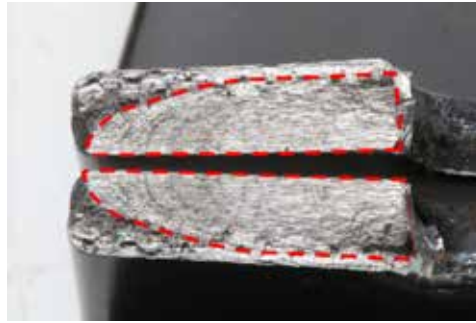
Figure 5. Fatigue region (inside the red dotted lines) and fatigue striations

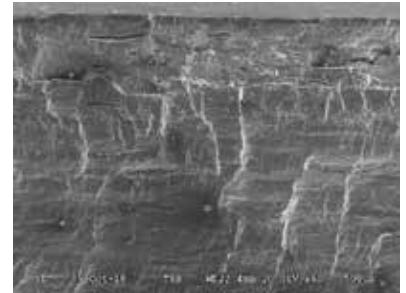
- The fracture surface of the fatigue crack was examined under the scanning electron microscope, and a significant number of secondary cracks were found parallel to and underneath the inboard surface of the base of the bracket (Figure 6). These cracks resembled material delamination.

Figure 6. Secondary and parallel cracks underneath the surface of the bracket
